Balch Creek Watershed

Good Policy, Poor Performance

ABSTRACT

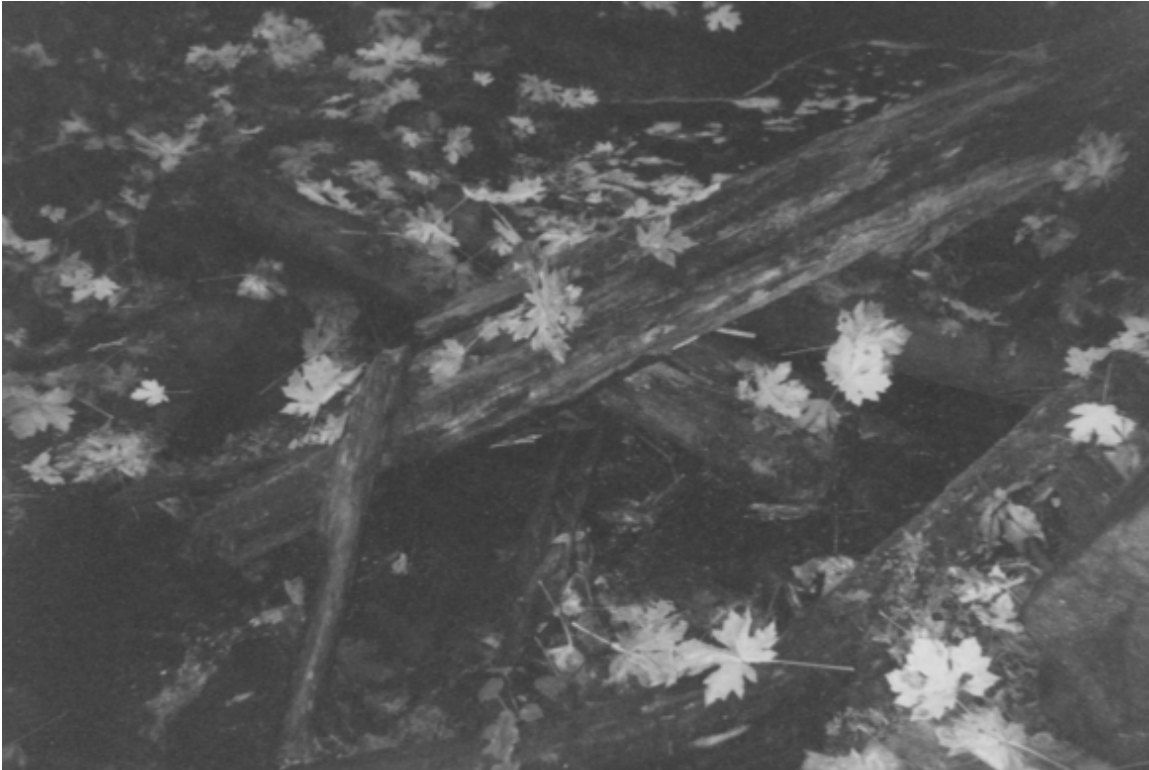
Fig. 1: Logs Placed in Stream Channel (November 5, 2002)

Logs and other debris are deliberately placed in the stream channel to provide enhanced cutthroat trout habitat. The debris provides shade and shelter for organisms within the stream. Placing logs in the channel also slows the current and allows for pooling in front of the placement (*Our Projects* 2002).

The IBI data clearly shows that the native cutthroat trout populations within Balch Creek live in a severely impaired environment. Although certain low maintenance solutions have been utilized such as placing logs in the stream channel (Fig. 1), little has been done to improve actual water quality. The two-four thousand trout within the creek live in a highly toxic environment (Graham and Ward 2002).

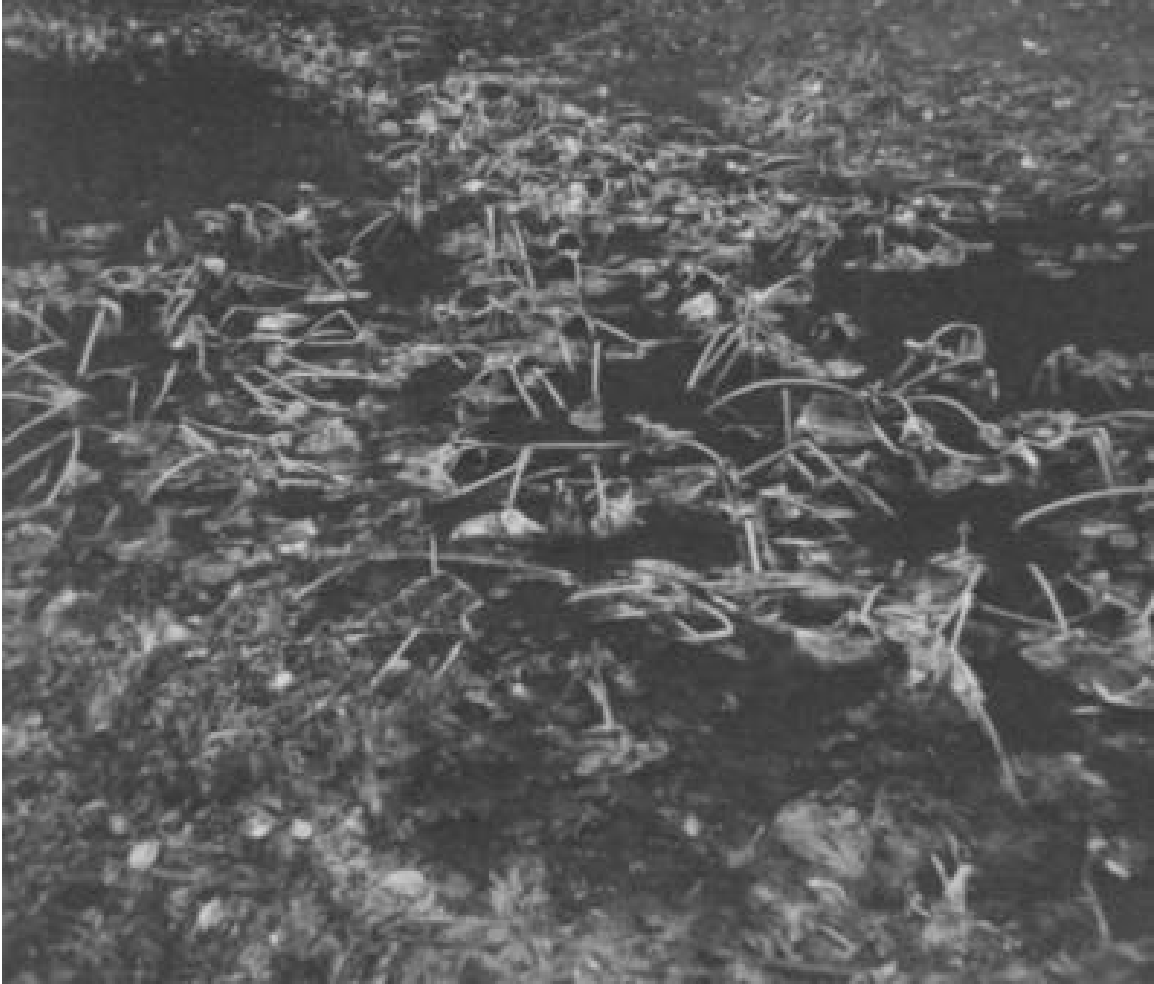
Fig 2: Native Plantings Within Balch Creek (November 5, 2002)

Wapato planted in ponds near the source of Balch Creek. These plants provide shade and organic matter to support existing trout and other vertebrate populations in the watershed. It is difficult to see in this photo but the foreground is riddled with footprints and animal tracks, despite conspicuously placed signage and railings.

The visual data demonstrates that caretakers of the watershed are fighting a losing battle. Areas had been cleared and replanted, most notably within the area of the Audubon Society section in reference to the ponds. Along the trails were patches of removed English Ivy and Himalayan Blackberry and markers indicating that the spot had undergone habitat restoration (Figs. 2 and 3).

Passive conservation methods such as signage and railings did little in terms of controlling recreational use throughout the watershed. Footprints and trampled vegetation were observed even at the base of some signs. It can be seen in figure 2 that even the most maintained portion of the watershed was not immune to pedestrian traffic. Dogs were also running through the watershed without leashes or supervision. Numerous times unsupervised dogs ran through vegetation and droppings littered the sides of the trails.

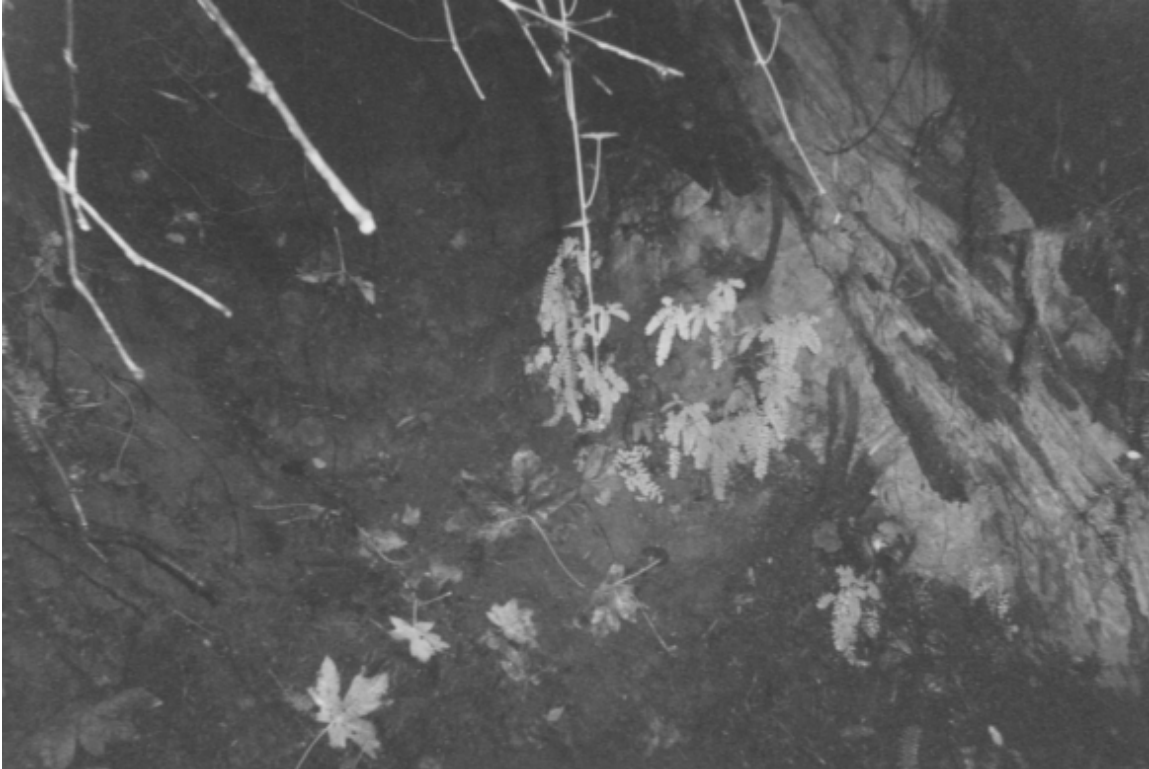
Fig. 3: Replanted Ferns Occupy Cleared Space (November 5, 2002)

Cleared space along a recreational path was replanted with native ferns to control erosion and restore native habitat to the watershed. Note the encroaching blackberry and morning glory vines overtaking the replanted area.

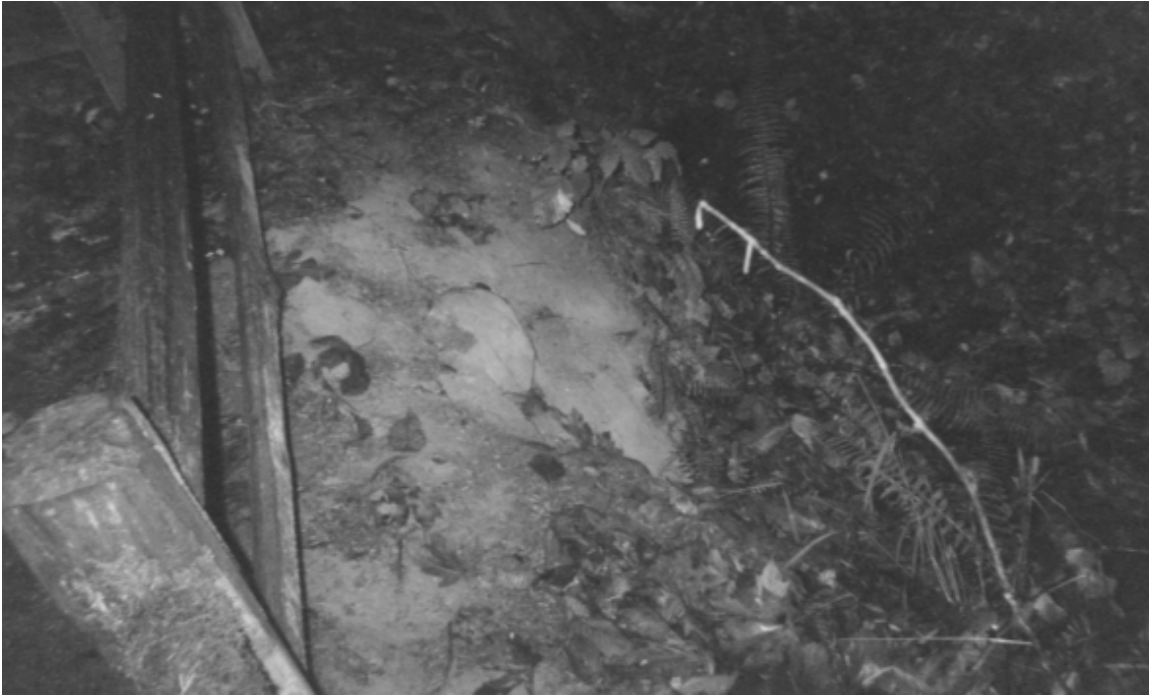
Fig. 4: Erosion of Stream bank Along Recreational Path (November 5, 2002)

A log placed along the recreational path decayed, making the steep slope susceptible to erosion. A lack of trailside vegetation has lessened the slope's capacity to prevent such degradation, causing it to crumble and erode into the stream channel. This type of erosion is a consistent problem along the trail running parallel to the creek (Grading and Erosion Control Permit Undated). Permeable sawdust was also spread along the trail at points to prevent erosion, but most had been washed away by rainfall or compacted by pedestrian use.

A visual analysis of the erosion control programs shows an initial effectiveness when the measures are first constructed. The logs along the trail edges shore up the pathways and stabilize the slope, preventing the bank from collapsing into the stream. There were several locations where the pins supporting the logs had come loose or were missing and the logs had rolled either downhill or were compromised. Other locations had been so neglected that the logs had decayed and crumbled along with the slope into the stream channel. Figure 4 is an example of a location where the log decayed, leaving the slope vulnerable to erosion.

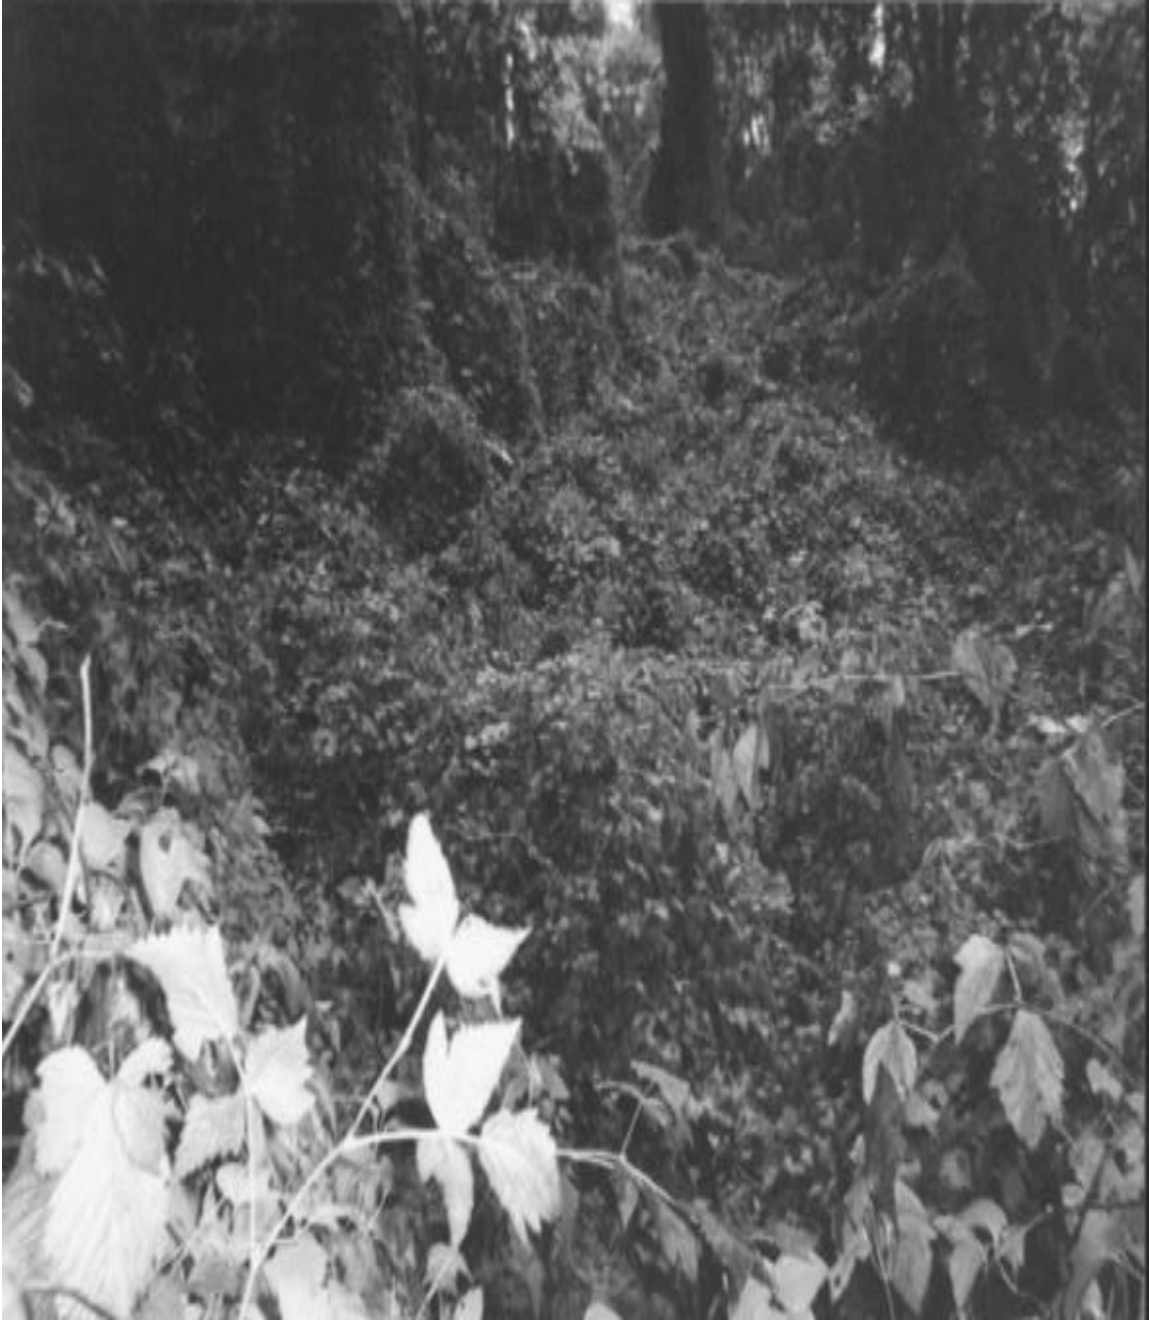
Fig. 5: Himalayan Blackberry Takeover of Balch Creek Watershed (November 5, 2002)

The entire hillside was covered with a combination of Morning Glory and Himalayan Blackberry. Most of the trees surrounding the watershed were also covered in a thick growth of English Ivy.

In areas that lacked maintenance, the invasive species overtook the replanted patches and swamped the native vegetation. Figure 5 is a good example of the dominant vegetation types along the creek. Aside from the recently planted areas, it appeared that most of the rehabilitated sections of the watershed had been overtaken by invasive species. A lack of upkeep doomed

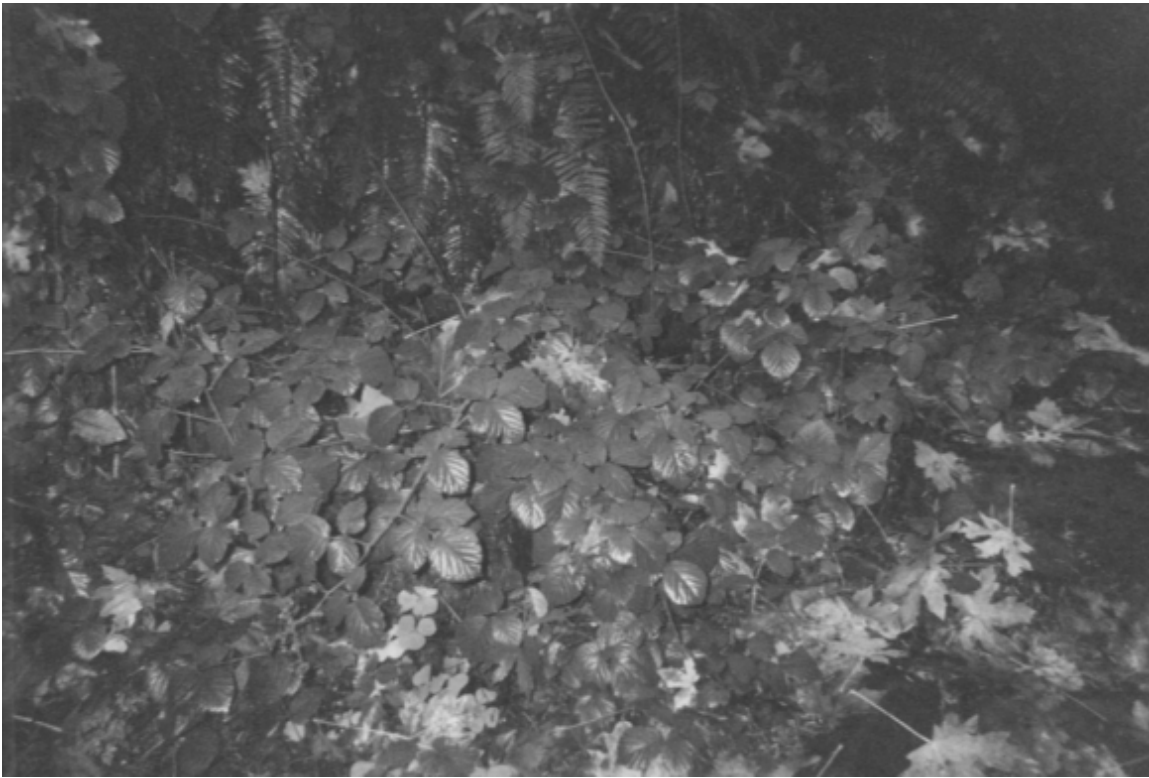
Fig. 6: Himalayan Blackberry Overtakes a Patch of Ferns (November 5, 2002)

A lack of upkeep led to the destruction of native fern replantings by invasive blackberries along the stream bank.

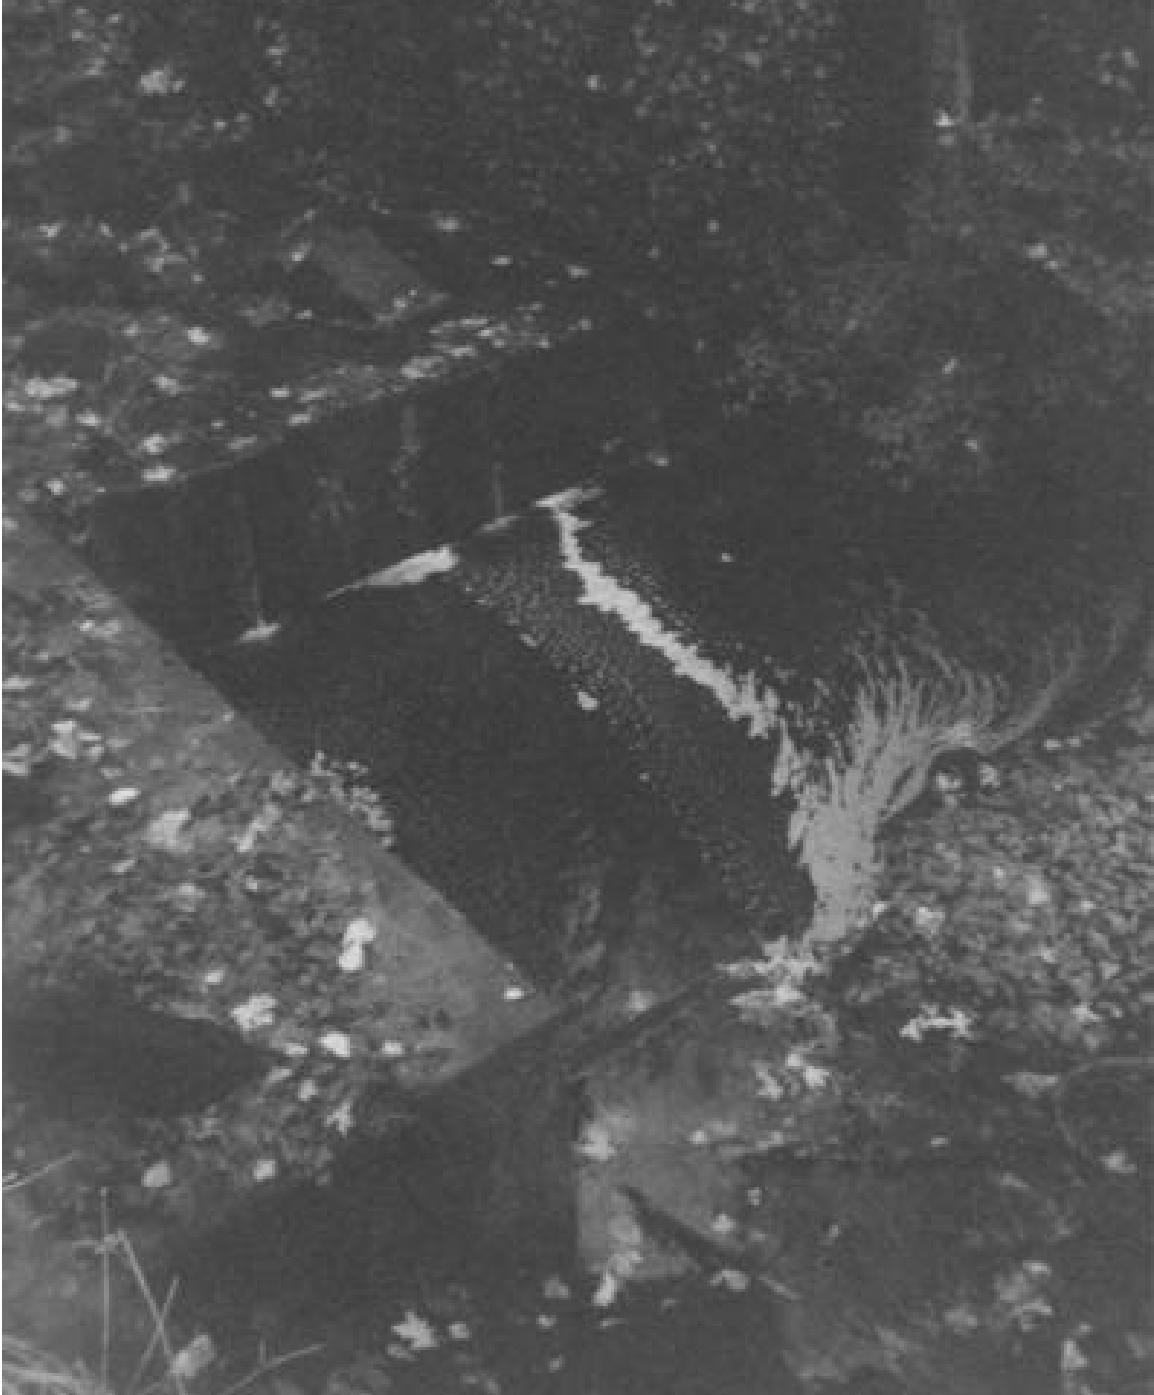
Fig. 7: Mysterious Foam on the Surface of Balch Creek (November 5, 2002)

Throughout the reaches of the creek, an odorless sudsy foam covered portions of the waterway. This picture demonstrates one of the larger patches of foam below an armored section of the channel. Note the wall of ivy to the right of the barrier. Lawn chemical runoff and other pollutants from nearby houses most likely caused this foam (BES BCW 2002).

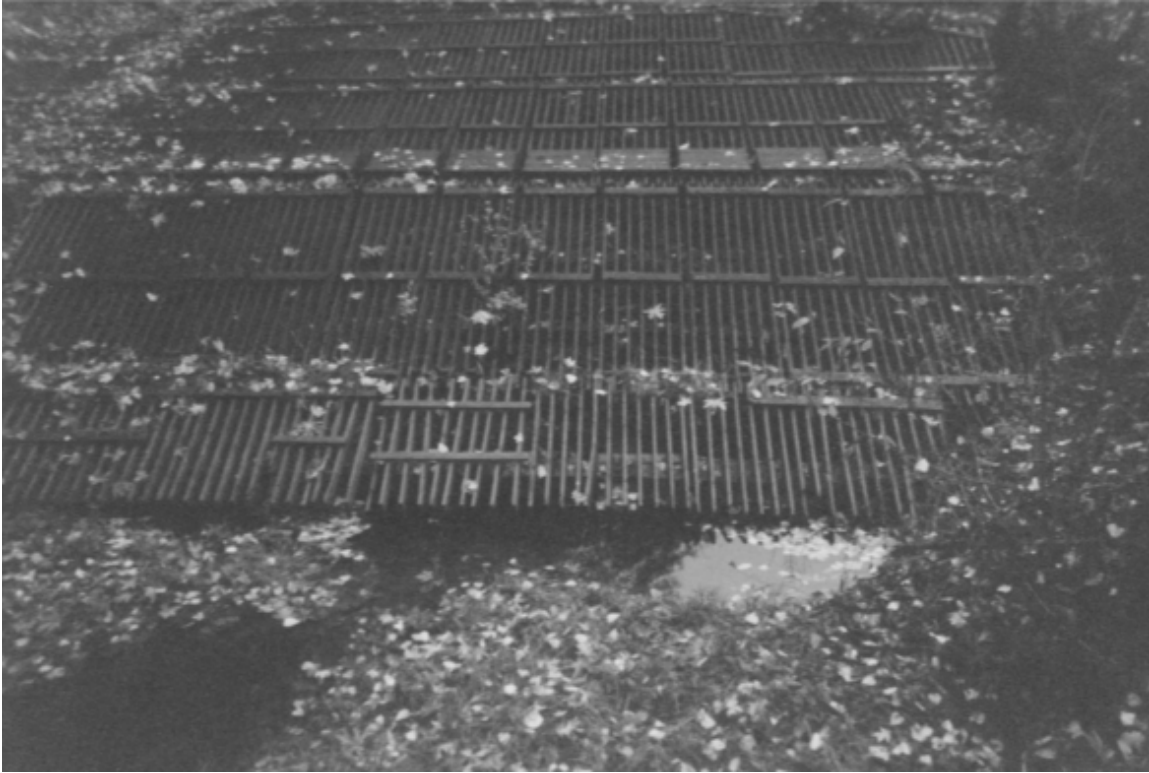
Fig. 8: Balch Creek Enters the City of Portland (November 5, 2002)

Balch Creek enters the combined sewer system of urban Portland at this wooden grate. This makes the upper reaches of the creek completely isolated from the Willamette River. Native populations of fish are trapped within the stream and have no interaction with new populations (Graham and Ward 2002).
